Mine Name: Developments 1

Operator Name: Decorative Developments

## Inspection Report Minerals Regulatory Program

Permit Number: S/035/0033 Inspection Date: 10/16/2008

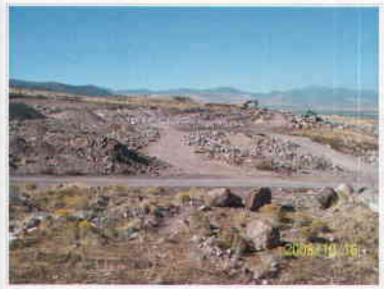
Northwest view of disturbance

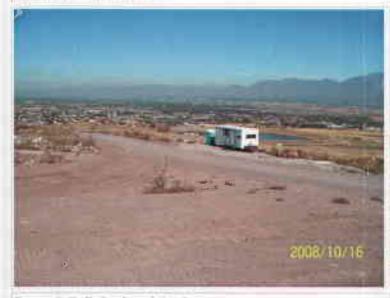
Equipment used on the premises - view of disturbance.

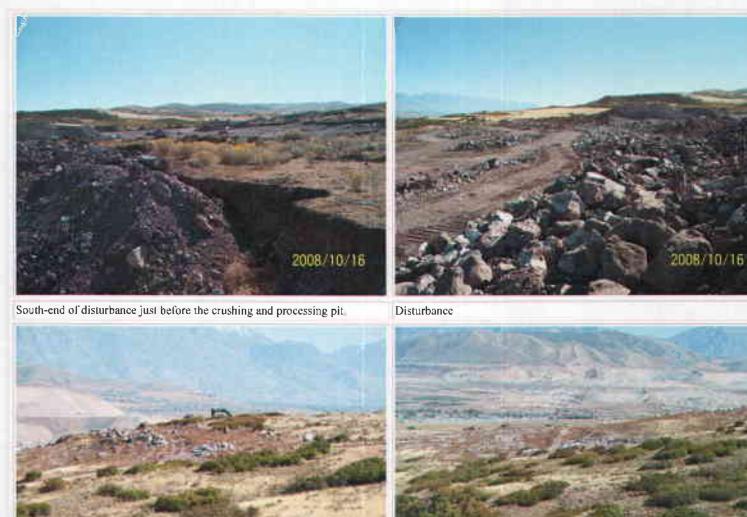
Recent mining extraction - disturbance

Southeast view of north face

North face disturbance
